DEPARTMENT OF THE ARMY
U.S. ARMY CORPS OF ENGINEERS
BOISE REGULATORY OFFICE
720 EAST PARK BOULEVARD, SUITE 245
BOISE, IDAHO 83712-7757

SUBJECT: NWW-2004-0600046, US-95 Thorn Creek Road to Moscow, KN 09294

DHP-NH-4110(156) US-95,
THORN CR RD TO MOSCOW, PH 1

Thorn Creek Road to Moscow Wetland Delineation Review and
Technical Report for Areas within the US-95 E-2 Alignment - September 22, 2020

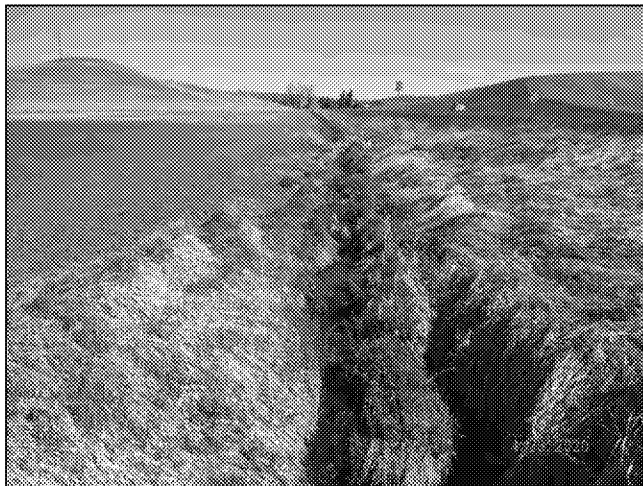
Areas along previously mapped and identified Tributary P (mapped by the topographic survey as Thorn Creek) were evaluated to see if wetlands were supported above the ordinary high water mark (OHWM). **Test site B1**, located on the east side of the tributary, confirmed wetlands are not supported near the beginning of the project along Tributary P. The OHWM was identified by a debris line and flattened grasses. Cropland is managed to the edge of the tributary on the west side.

Figure 1. Looking north along Tributary P.

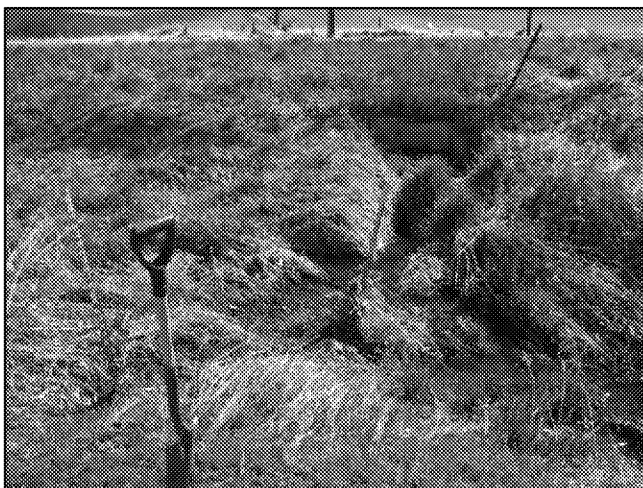
Test site B2 was located on the west side of Tributary P and did not confirm wetland presence above the OHWM. The tributary appears to be excavated and maintained in this area. The adjacent cropland appears to have been tiled out (as evident from the drain tile outlet shown in Figure 2 near the cross culvert of Thorn Creek under existing US-95).

Figure 2. Tributary P near the cross culvert of Thorn Creek under existing US-95.

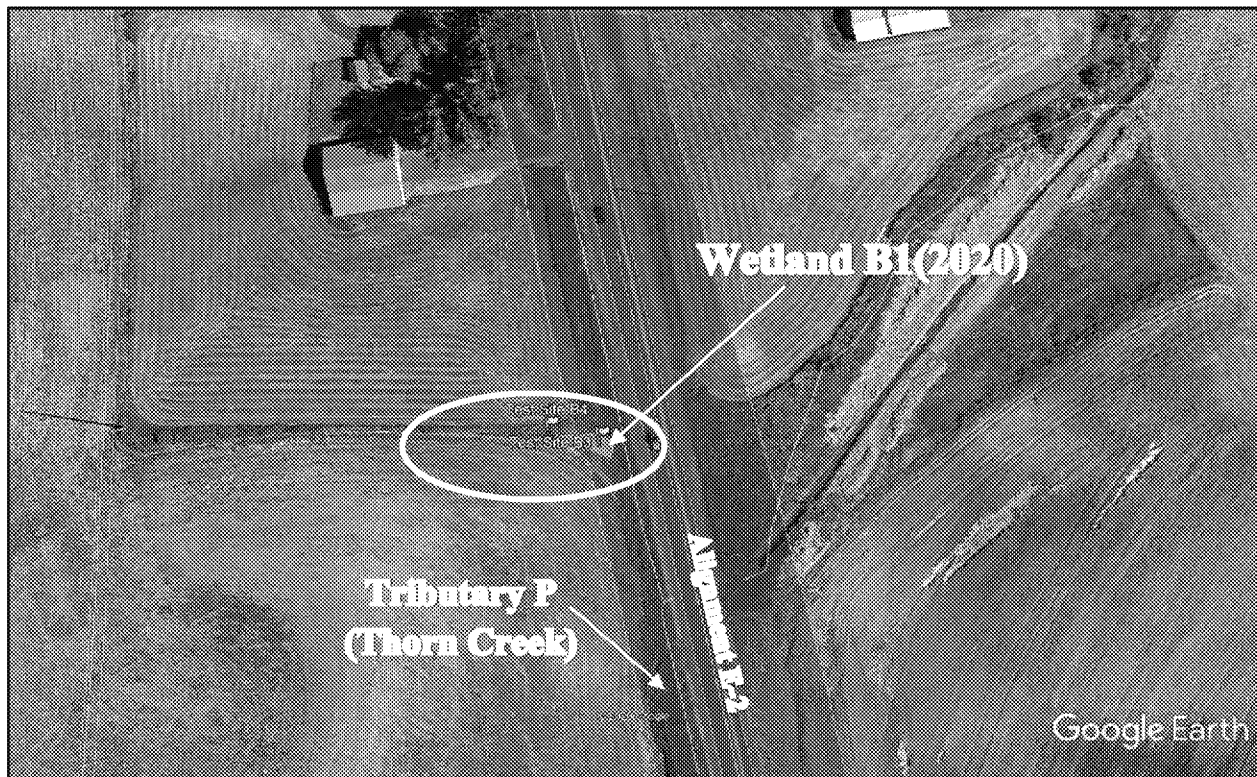
Figure 4. Location of test sites B3 and B4 and Wetland B1(2020).

Tests Sites B3 and B4 confirmed the presence of a Category III grass-dominated slope wetland along a small drainage pattern in the cropland (rating forms located in the appendix). Wetland presence has not been mapped in this location by previous reports or field reviews. The emergent wetland, referred to as **Wetland B1(2020)** is dominated by grasses and grass-like plants and extends upstream outside of the project area along a small east-flowing drainage pattern through croplands. The wetland is adjacent to Tributary P. Hayland borders the wetland on the north and cropland on the south side. Some snowberry, rose, and Canada thistle were present outside of the wetland boundaries on the north side.

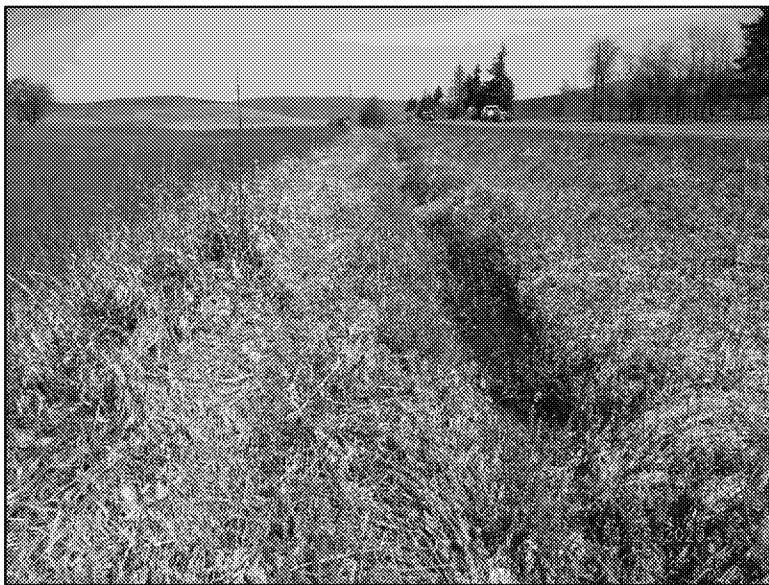
Test Site B5 was on the west side of Tributary P (upstream of the cross culvert carrying Thorn Creek as identified by the topographic map) in a grassy area. Tributary P in this area appears to be a roadside drainage ditch that is maintained (cleaned and channelized periodically). A small drainage pattern was visible in this area as evident by brighter colored and slightly more vigorous grass growth. Wetlands were not found to be supported in this location; it was observed that the surface water level in the tributary is too low in elevation to support prolonged soil saturation in the adjacent field.

Figure 6. Looking north along Tributary P near Test Site B5.

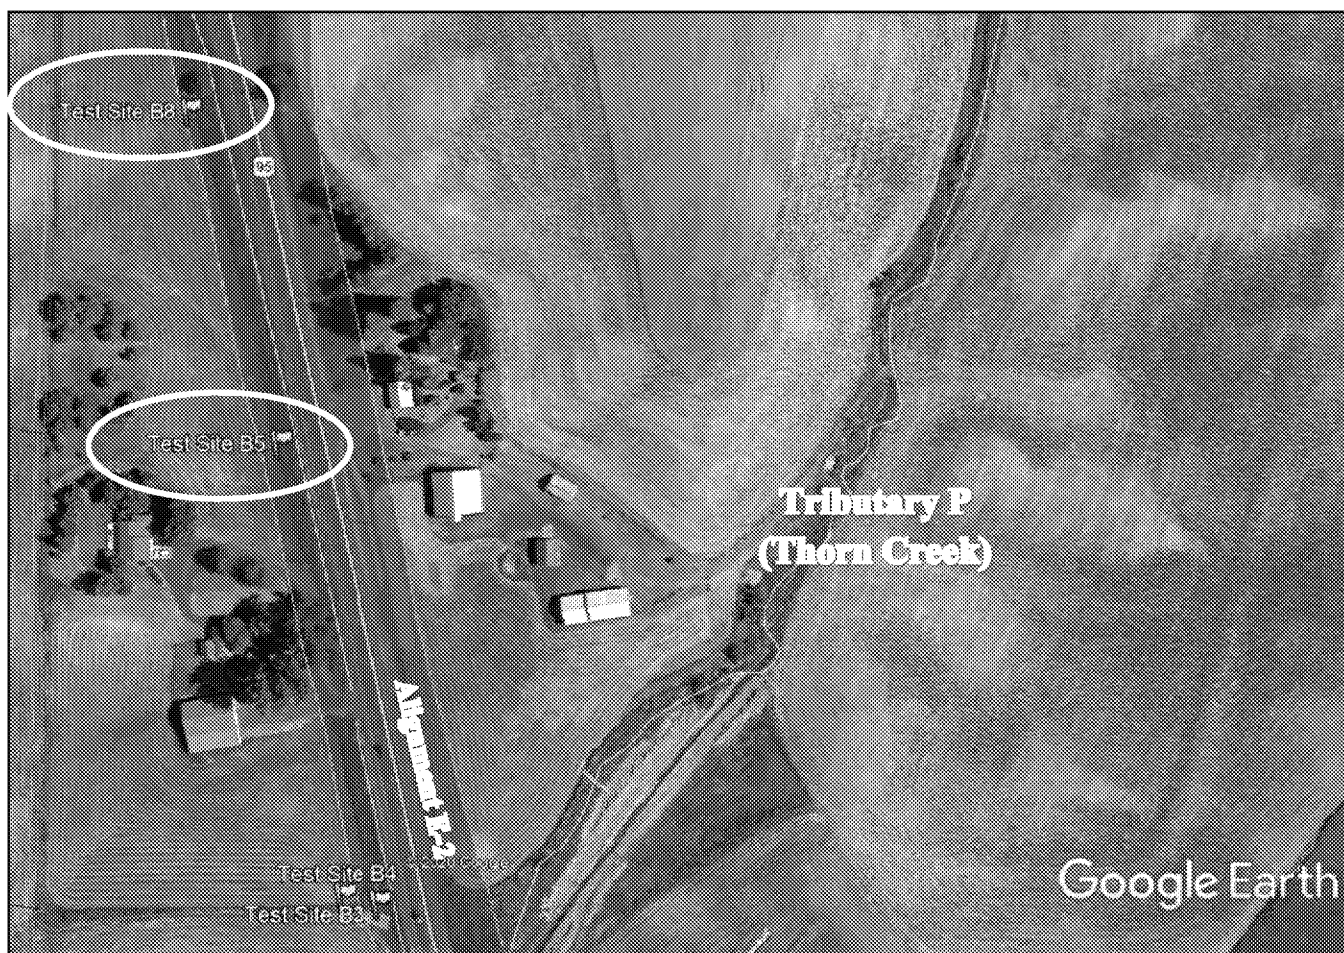
Figure 7. Location of Test Sites B5 and B8.

Test Site B8 was located in a small drainage pattern on the west side of the main tributary. Wetlands were not found to be supported in this location. A field drain tile outlet was identified near this area.

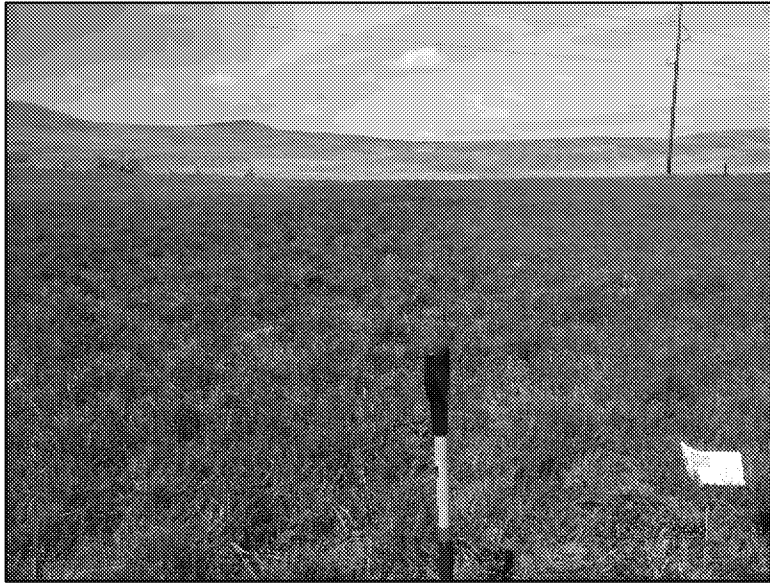
Figure 8. Looking west at Wetland 23A(2020).

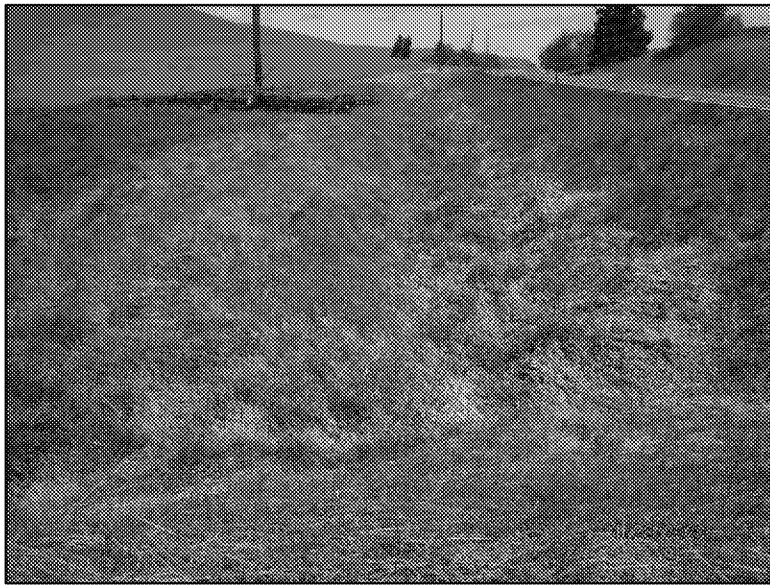
Test Sites B9 and B10 were also used to confirm the presence of wetlands. The grass and grass-like plant dominated wetland was delineated. The emergent wetland, once mapped as the northern branch of Wetland 23, is smaller than the previously mapped wetland. It appears that sediment has collected in this grassy low-gradient area and minimized the size of the previously mapped wetland. The wetland is on the west side of the main tributary/drainage ditch. The Category III slope wetland is identified by this report as **Wetland 23B(2020)**.

Figure 9. Looking north (upstream) at tributary/drainage ditch from field access near Wetland 23B(2020).

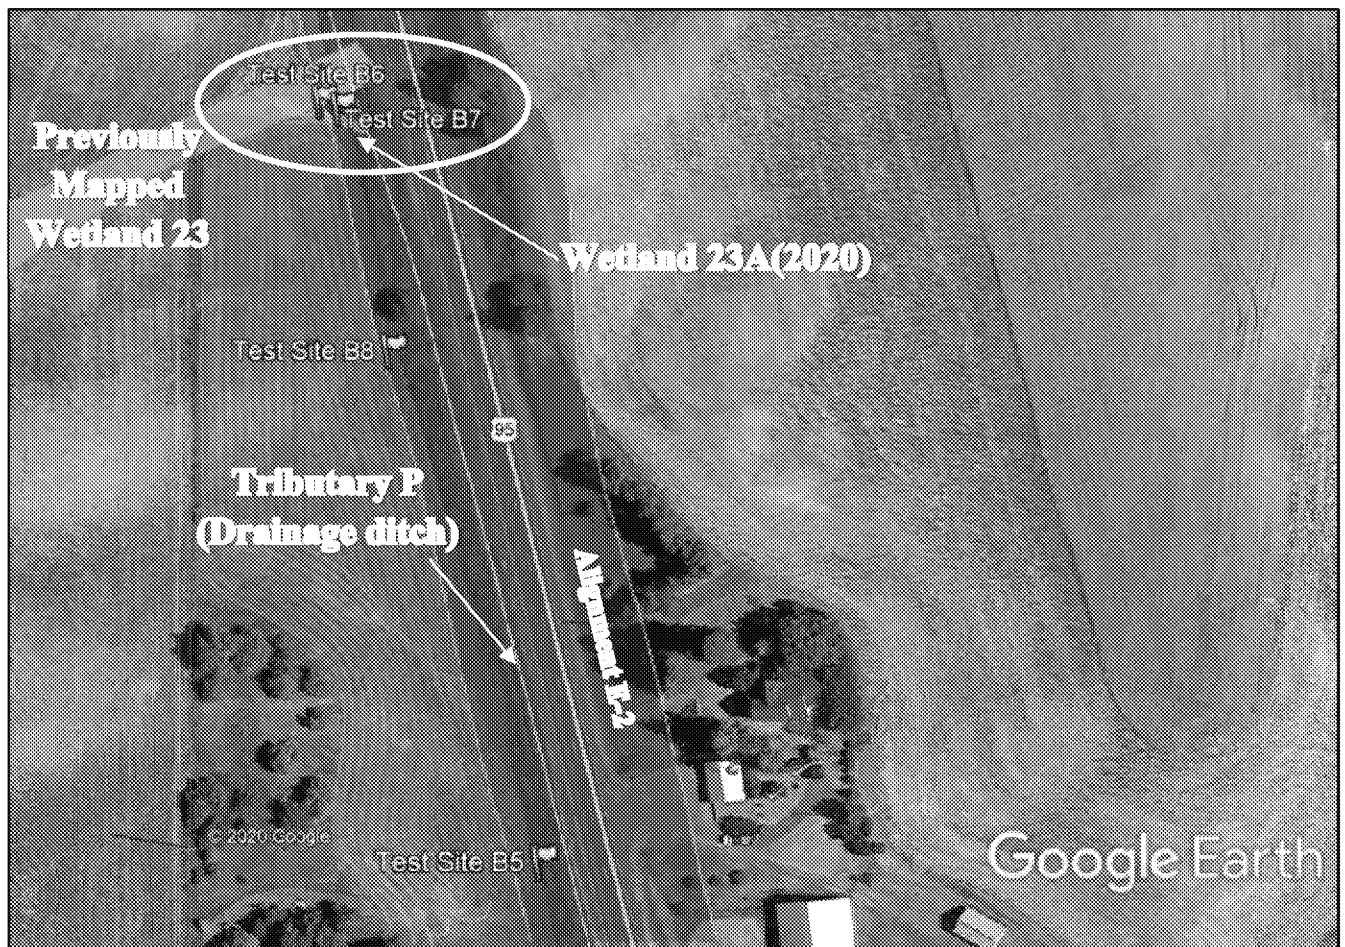
Figure 10. Location of Test Sites B6 and B7 and Wetland 23A(2020).

Test Sites B6 and B7 were used to confirm the presence of a wetland in this area. The grass and grass-like plant dominated wetland was delineated. The emergent wetland, once mapped as the southern branch of Wetland 23, is smaller than the previously mapped wetland. The wetland is on the west side of the main tributary/drainage ditch. The Category III slope wetland is identified by this report as **Wetland 23A(2020)**.

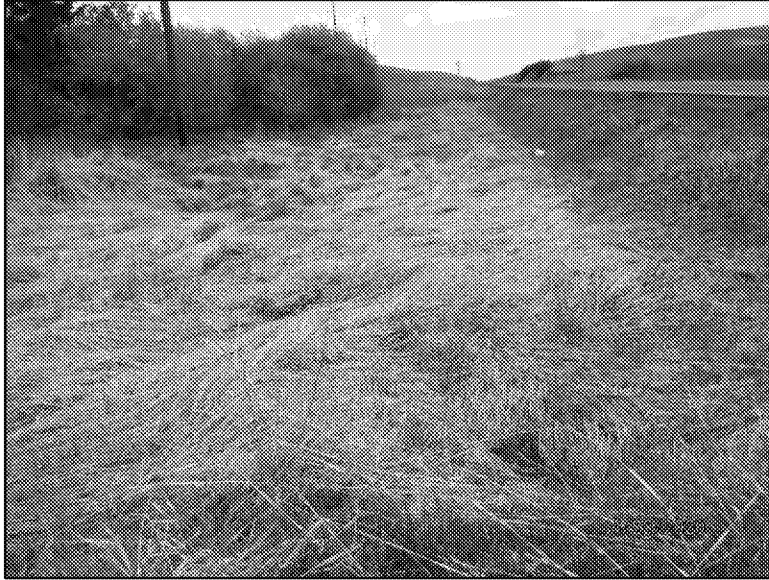
Test Site B11 was located in an abandon farmstead area on the west side of the existing highway. Wetlands were not found to be supported in this location. A culvert under the property access looks to be partially plugged, and there was some saturation at about 16 inches from the top of the test pit. The overland flow from the site travels in a southerly direction to the tributary/drainage ditch. Soils do not appear to stay saturated into the growing season.

Figure 12. Looking north along the existing highway at Test Site B11.

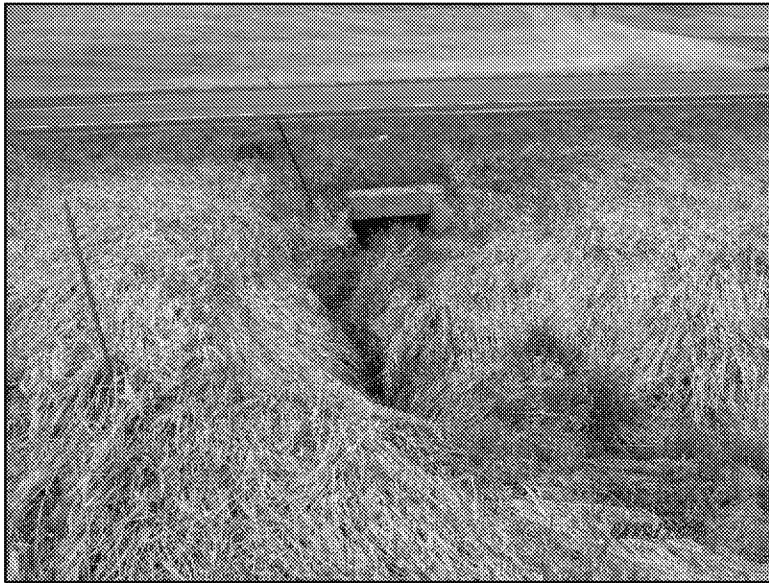
Test Site B12 was located on the north side of Tributary P (mapped as Thorn Creek). The tributary has been cleaned out with the excavated material deposited on the north side of the channel. The surface water elevation is lower at OHWM and does not appear to support wetland characteristics adjacent to and above the OHWM. The OHWM was not very evident, although a scour line on the bank was evident. The south side of the tributary slopes up and away from the top of bank. The downstream end of the box culvert, which carries the tributary in a southwesterly direction, was channelized and appeared to be recently cleaned out. Wetlands were not found to be supported adjacent to the tributary within the alignment. The area was once mapped as **Wetland 28**.

Figure 14. Discharge point at box culvert of the tributary (mapped as Thorn Creek).

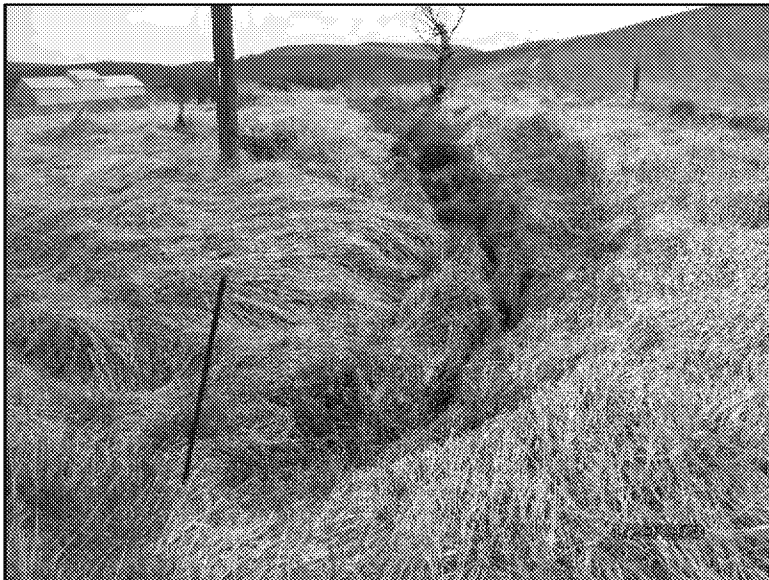
Figure 15. Looking upstream at the tributary near Test Site B12.

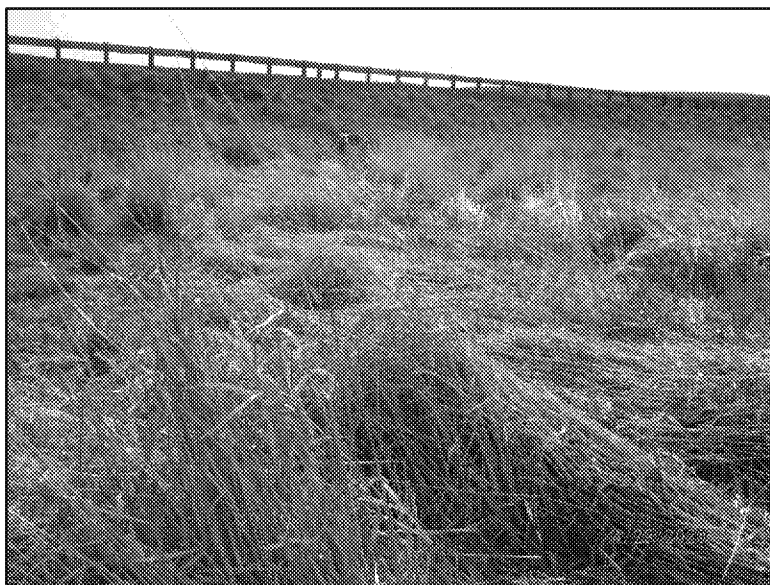
Test Site B13 was located below a cross culvert at the top of a drainage draw on the west side of the existing highway. The gradient in this area is steep and the site does not appear to allow soils to stay saturated into the growing season. Wetlands were not found to be supported in this location.

Figure 17. Looking southeast at Test Site B13.

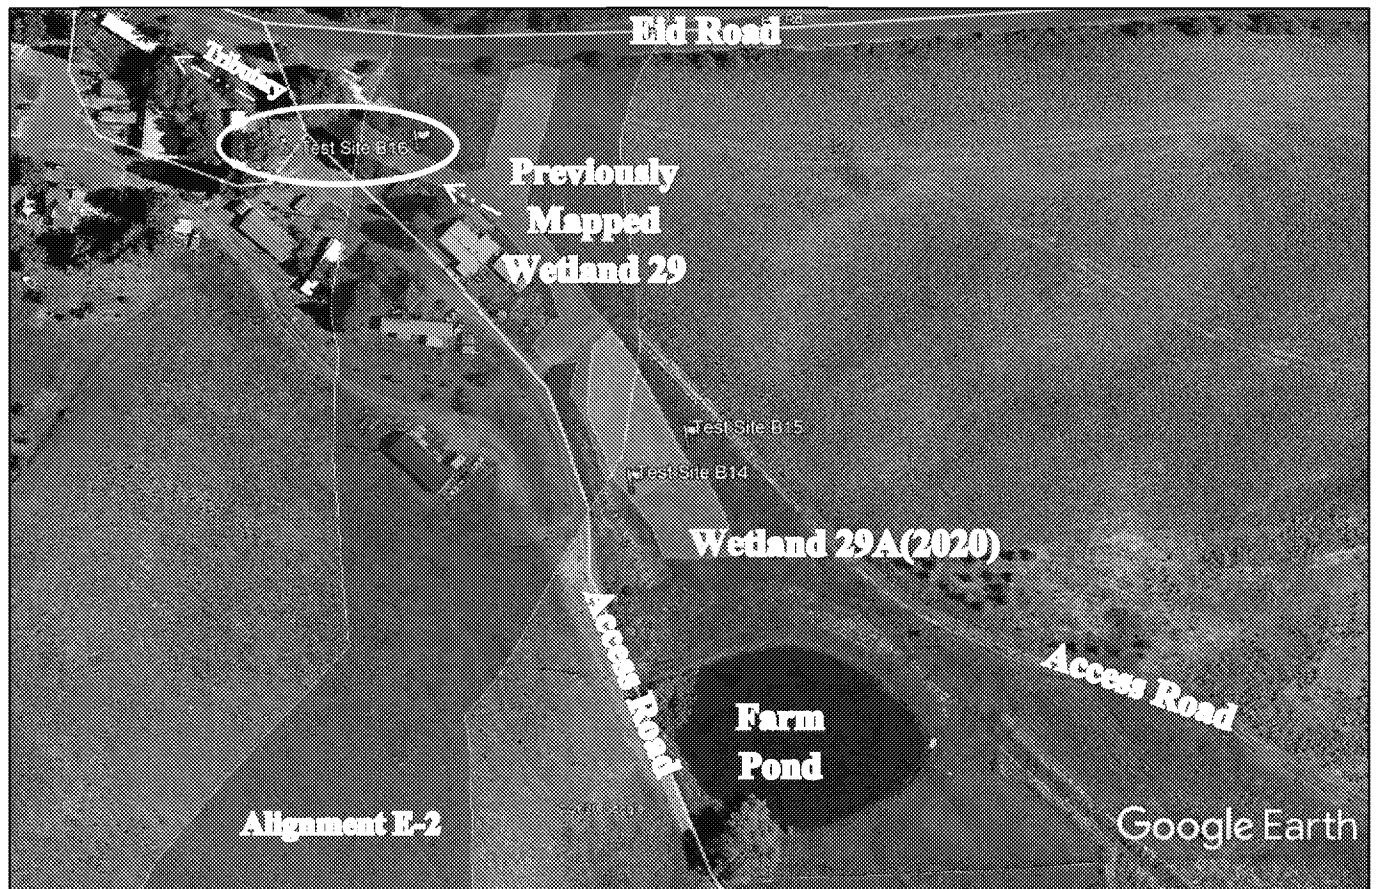
Figure 19. Location of Test Sites B14, B15, and B16, and Wetland 29A(2020).

Test Site B14 was located below a farm pond in a grassy area along between two access roadways on the south side of Eid Road. This test site was in a grassy area that was noticeably more green with new growth than some of the other areas across the reed canarygrass field. The test site confirmed the presence of a Category III slope **Wetland 29A(2020)** (previously mapped Wetland 29). The emergent wetland is dominated by grasses and appears to receive its hydrology from the pond overflow or leakage. The wetland is confined by the landform on the west and east side where the toe of the road fill slopes up and away from the lower part of the field. The wetland drains through a culvert in an access roadway to previously mapped tributary, which is confined to its banks. **Test Site B15** verified the wetland/nonwetland boundary of Wetland 29A(2020).

Test Site B16 was located on the north side of the tributary/drainage ditch below Wetland 29A(2020) on what looked like a small floodplain bench. Wetlands are not supported above the OHWM (as observed by a scour line on the right bank (looking downstream)). The gradient of the tributary/drainage ditch steepens downstream of this test site area, where the tributary flows through a culvert and becomes more channelized/downcut and streambanks become steeper. The tributary looks as if it has recently been cleaned out.

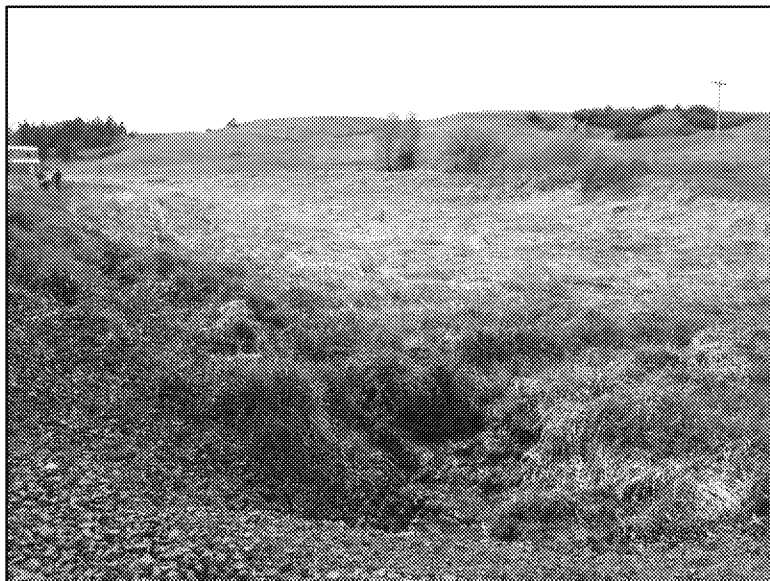
Figure 20. Looking southeast at Wetland 29A(2020).

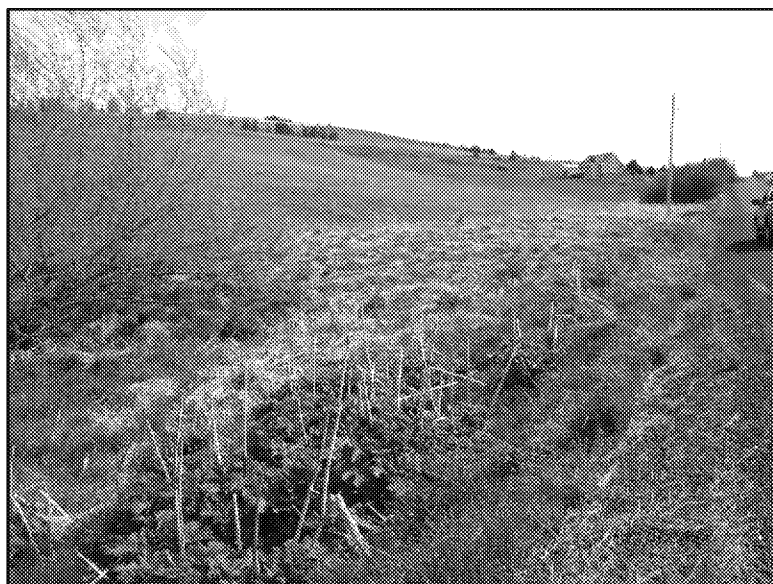
Figure 22. Looking east (upslope) at Wetland 29B(2020), north of Eid Road.

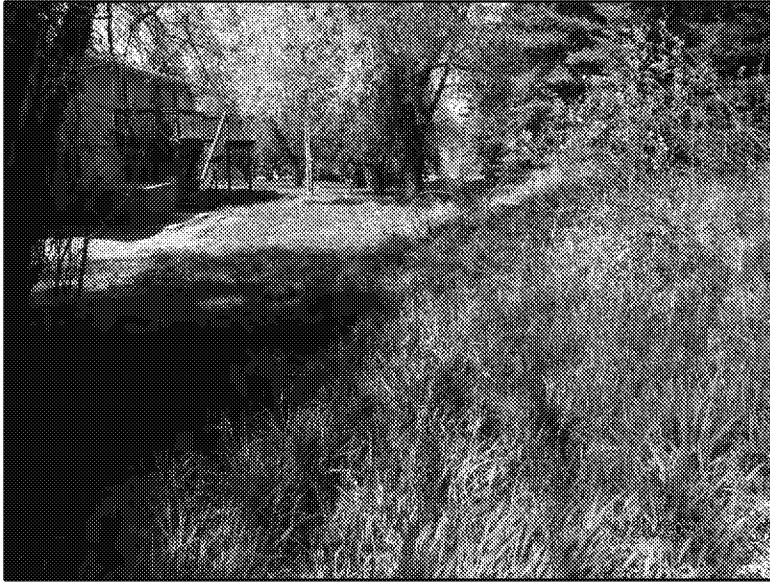
Figure 23. Looking downstream at the tributary below Wetland 29B(2020).

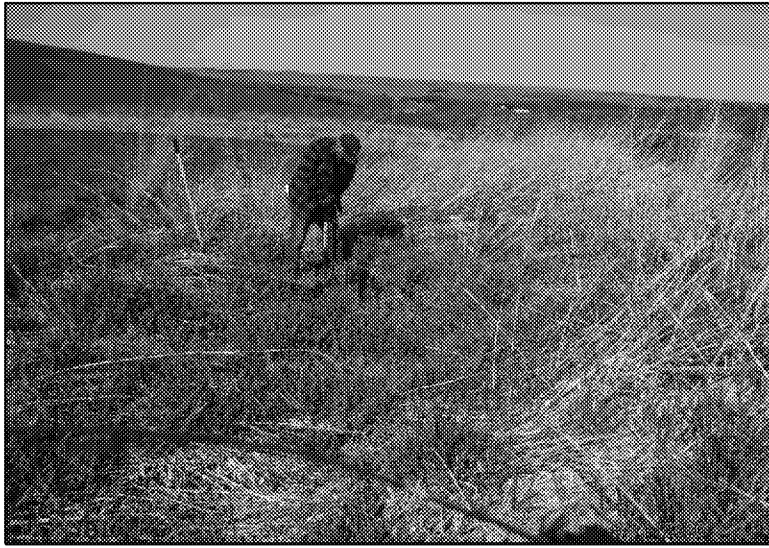
Test Site B21 was located in the drainage draw above a farm pond and below a brushy area. The drainage draw was previously mapped as the northern branch of **Wetland 32**. The land appears to be built up with sedimentation. The area supports mullien and cow parsnip as well as reed canarygrass. The soils do not indicate that they stay saturated into the growing season. **Test Site B22** was located in the drainage pattern to the south of Test Site B21. The test site was dug in a small ditch bottom. The drainage pattern appears to have been drained possibly with drain tile with cropland encroaching in on the sides. The pond below the drainage draw was flowing a small amount of surface water at the time of this site visit, but no surface water (or saturated soils) were present in the drainage draw. Wetland 32 is no longer supported in this area.

Figure 25. Location of Test Site B21, looking downslope.

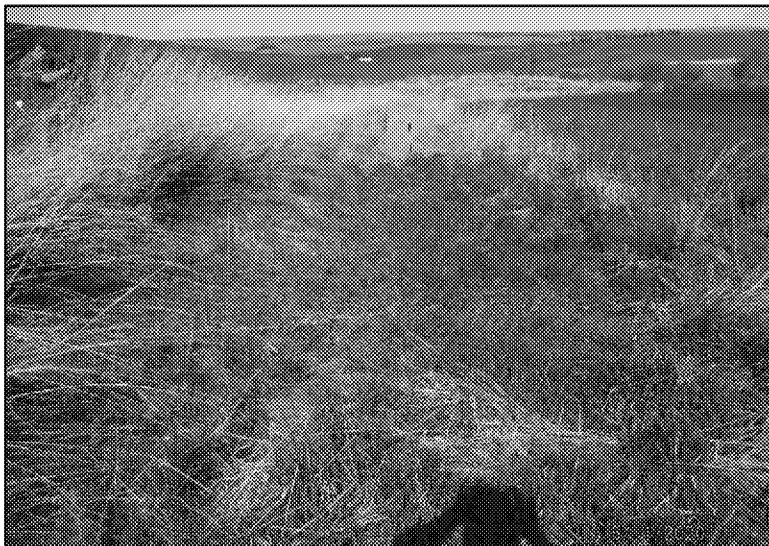
Figure 26. Location of Test Site B22, looking downslope.

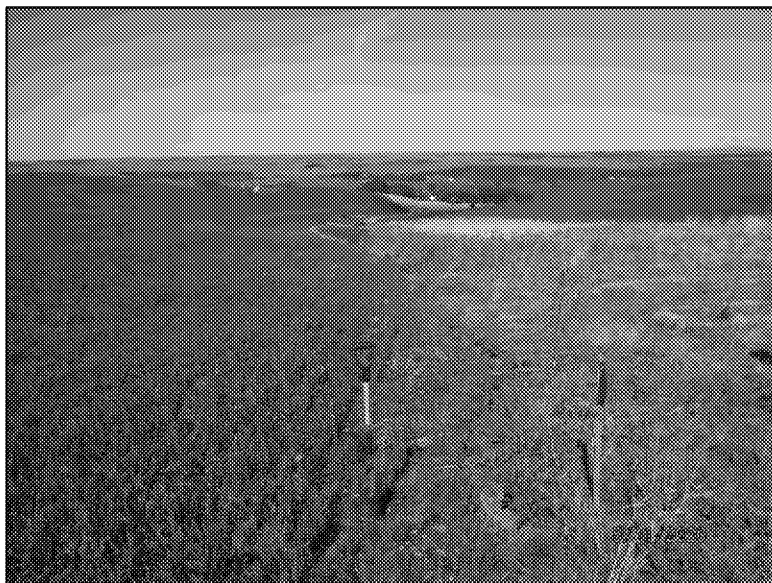
Test Site B23 was located in near a drainage draw once mapped as **Wetland 44**. The drainage draw is now approximately 8 inches wide (approximately 6 inches deep) and a dry, scoured drainage ditch with exposed rocks. The draw is at a relatively steep gradient. Hydric soil characteristics in the small drainage pattern are supported, but thought to be relic soil characteristics, wetland hydrology was not supported. Wetland 44 is no longer supported within the alignment in this area.

Figure 28. Looking downstream at the drainage draw and Test Site B23.

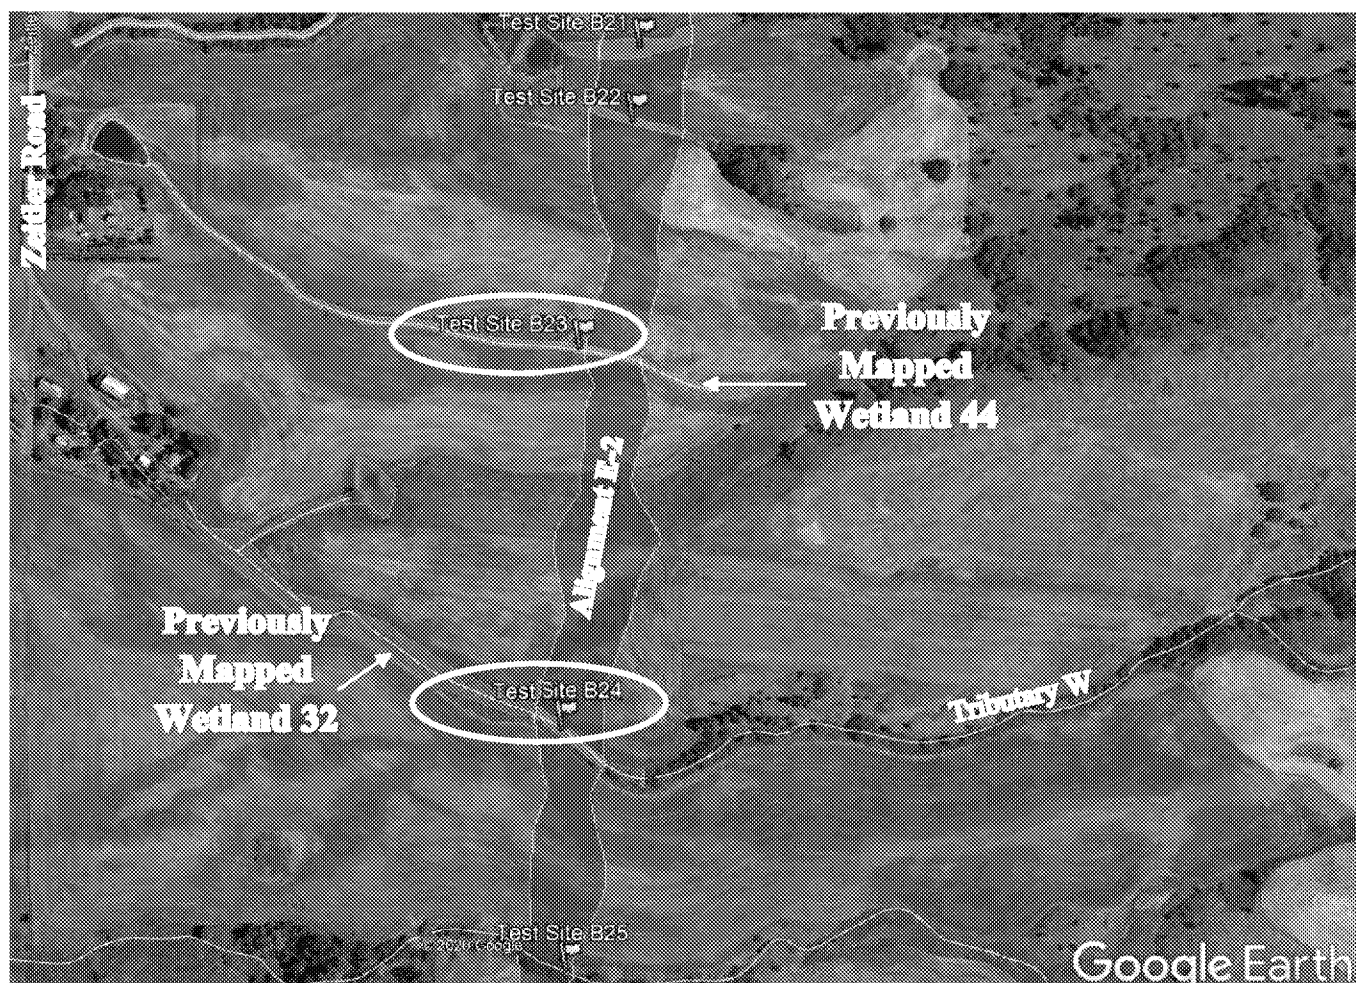
Figure 29. Location of Test Sites B23 and B24.

Test Site B24 was located in a small drainage draw, which was previously mapped as the southern branch of **Wetland 32**. A small, narrow drainage ditch runs through the center of the drainage pattern, previously identified as Tributary W. Snowberry and roses were along the edge of the drainage pattern. Wetland 32 is no longer supported in this area.

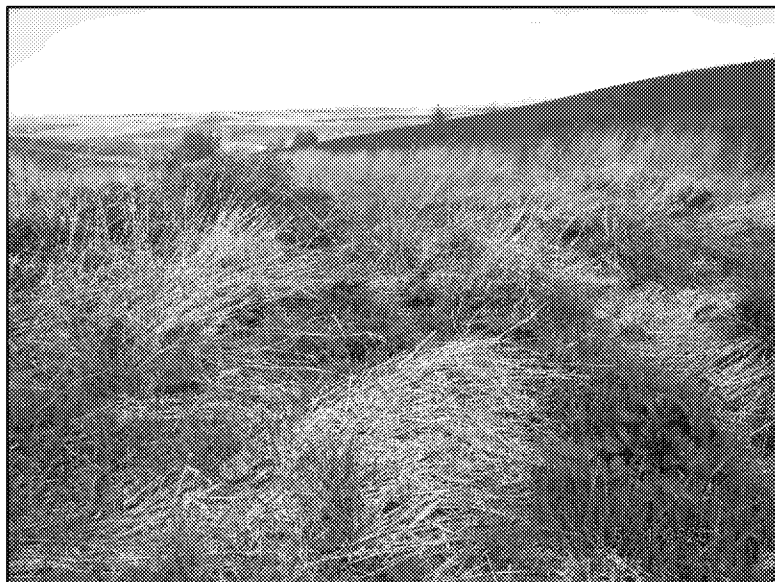
Figure 30. Looking downstream from Test Site B24. Tall grass (last year's growth in the picture) was determined to be tall or intermediate wheatgrass (no hydrophytic vegetation indicator status).

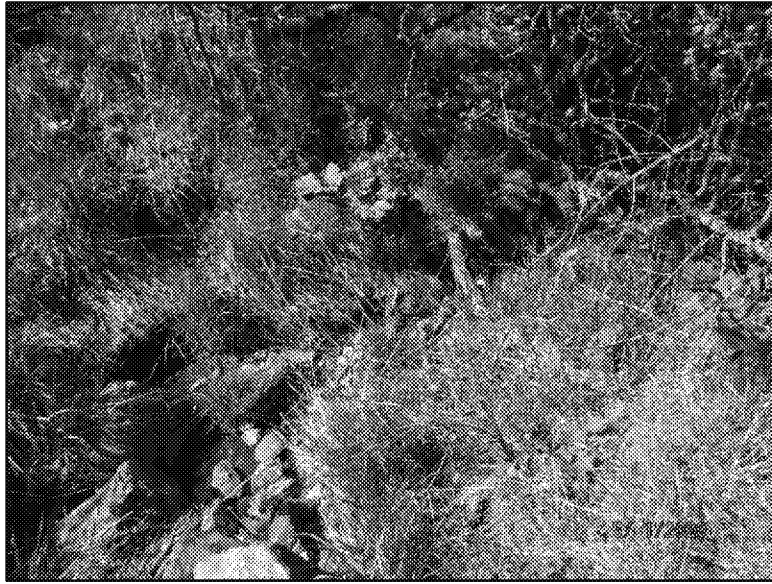
Test Site B25 was located on the north side of a previously mapped tributary (Tributary V) to rule out wetland presence adjacent to the tributary within the alignment. Wetlands are not supported above the OHWM of the tributary. The tributary is deep with large, exposed rocks and on a relatively steep gradient. The test site (and western side of the alignment) is near (upstream) of a 36 inch culvert with a small amount of flowing water at the time of this site visit. The land at the top of the banks slopes up and away from the tributary. The tributary is relatively deep and soils above the OHWM do not appear to stay saturated into the growing season.

Figure 31. Looking downstream at Tributary V from Test Site B25.

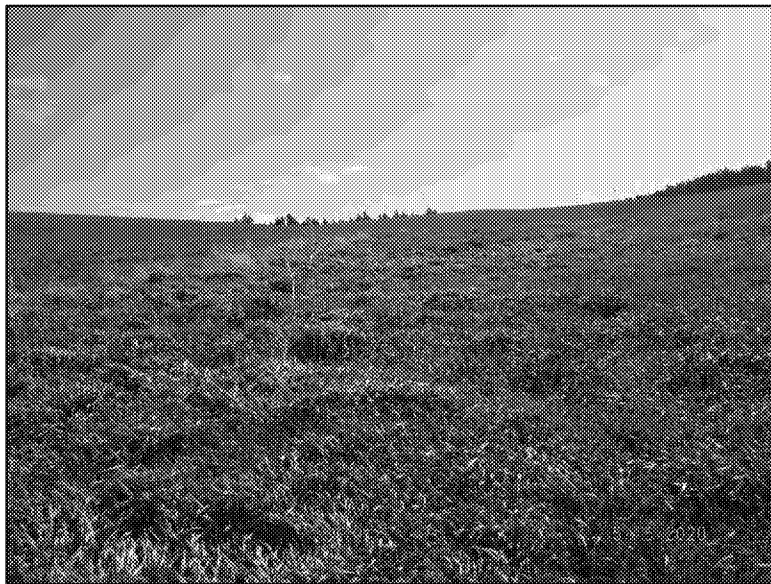
Test Site B27 was located in the drainage pattern associated with the northern branch of the area previously mapped as Wetland 35B. The test site was located in a grassy drainage way surrounded by cropland planted to wheat. There was some standing water present. This test site determines support of wetland characteristics referred to as a Category III slope **Wetland 35B(2020)**. **Test Sites B28 and B29** support the wetland/nonwetland boundaries of Wetland 35B(2020). A mounded area (likely a rocky outcrop) dominated by upland vegetative species is located to the south of Wetland 35B(2020) and north of the drainage pattern described in Test Site B26. Wetland 35B(2020), an emergent wetland, is smaller than the previously mapped Wetland 35B, which is no longer supported as previously mapped. Overland flow from the wetland appears to travel downslope through a nonwetland grassy area and cropland; the cropland on the edge of the grassy area was in winter wheat with weed growth (scented mayweed). It is also assumed that the surface water from the wetland may find its way to the rocky substrate indicative of the rock outcrop as previously discussed. Surface water from Wetland 35B(2020) flows to a tributary network previously identified as Tributary W.

Figure 33. Looking upslope at Wetland 35B(2020).

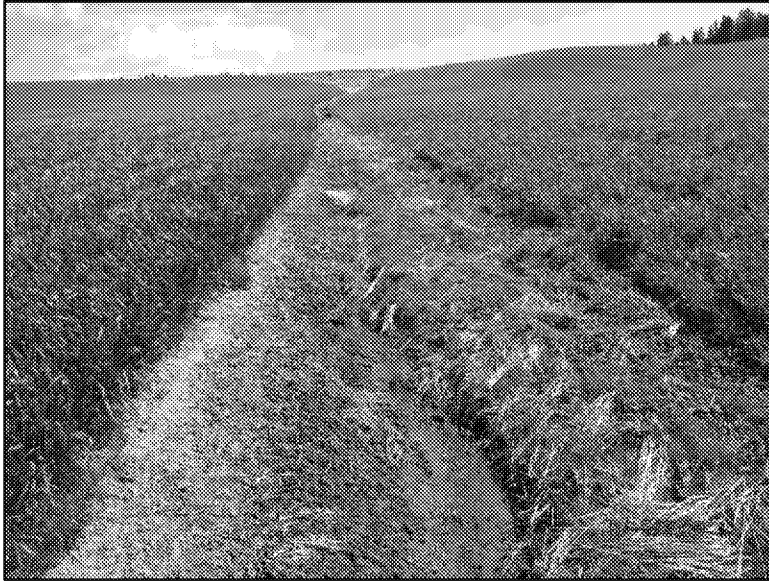
Test Site B32 was located in a farmed field drainage pattern where a scoured ditch appears to carry surface water flow (the ditch was approximately 12 inches wide and 4 inches deep with relatively steep side slopes along the ditch). The previously mapped northern branch of Wetland 35A is no longer supported in the area as farming practices have appeared to shape the land in such a way that the wetland features are now better described as a tributary.

Figure 35. Looking upslope at Test Site B32, previously mapped as the northern branch of Wetland 35A.

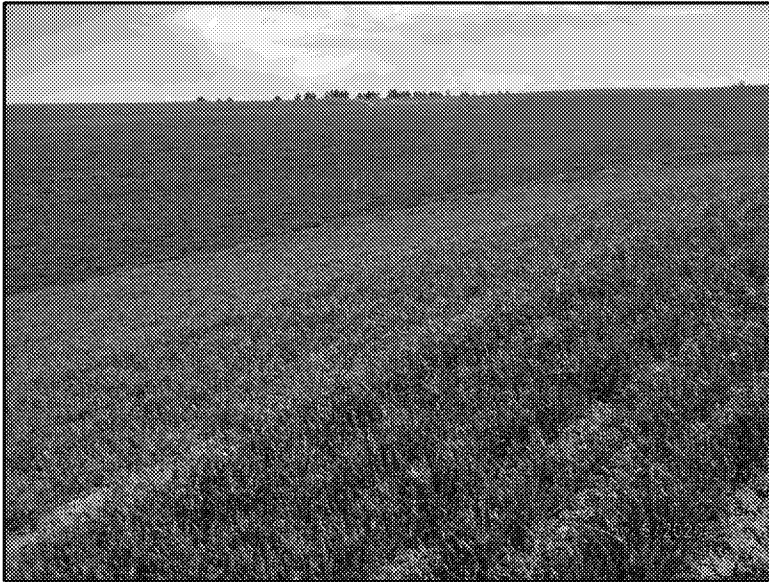
Figure 36. Looking north at Wetland 35A(2020).

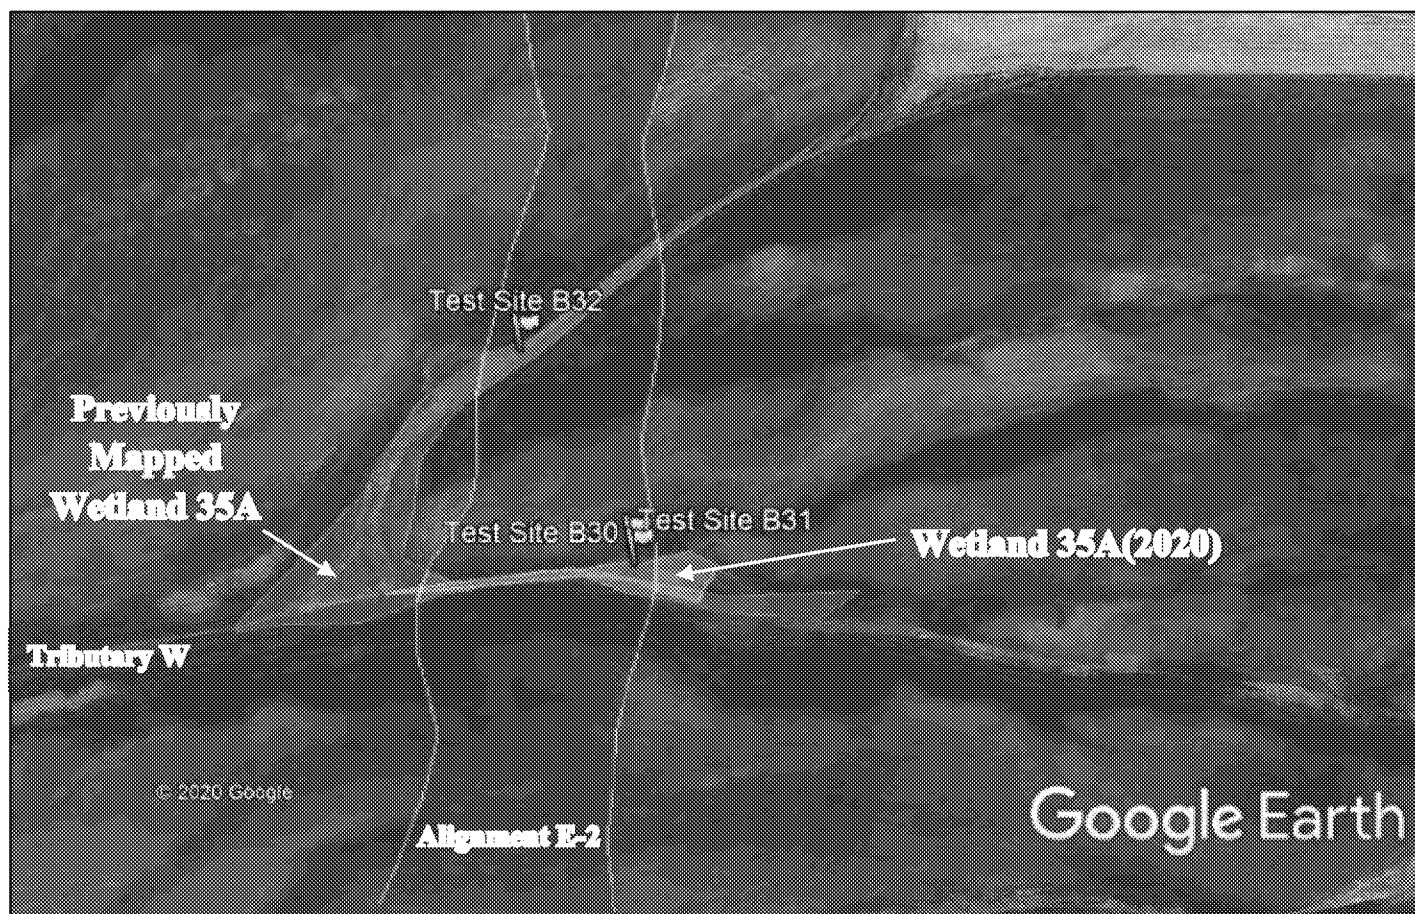
Figure 37. Location of Wetland 35A(2020) and Test Sites B30, B31, and B32.

Test Site B30 was located in a farmed field near a drainage pattern. The site is an agriculturally managed plant community (planted to winter wheat). The wetland area presented soils wet to the surface during the site visit, which defined the boundaries of the wetland. Judging from other test sites in the project area, if the field had not been managed for weed growth and planted to a crop, it would likely support reed canarygrass or meadow foxtail (both FACW wetland indicator status). The site would best be described as a farmed wetland. A small amount of surface water was flowing in the narrow wetland at the time of this site visit, and appears to be coming from a hillside seep. The wetland had previously been mapped as the southern branch of Wetland 35A, with boundaries re-delineated and now referred to as Category IV slope **Wetland 35A(2020)**. **Test Site B31** confirmed the wetland/nonwetland boundary of Wetland 35A(2020), which extends up and downslope of the E-2 alignment.

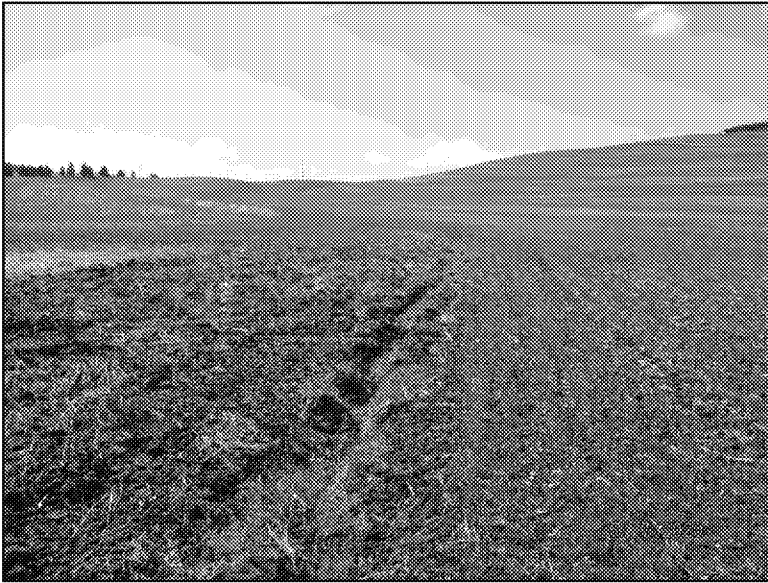
Figure 38. Looking upstream from Wetland 40(2020).

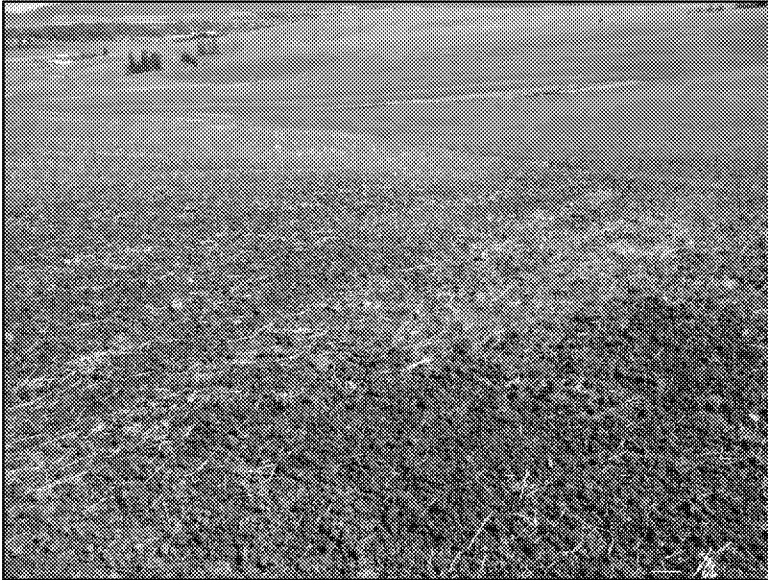
Figure 39. Looking downslope from Test Site B36.

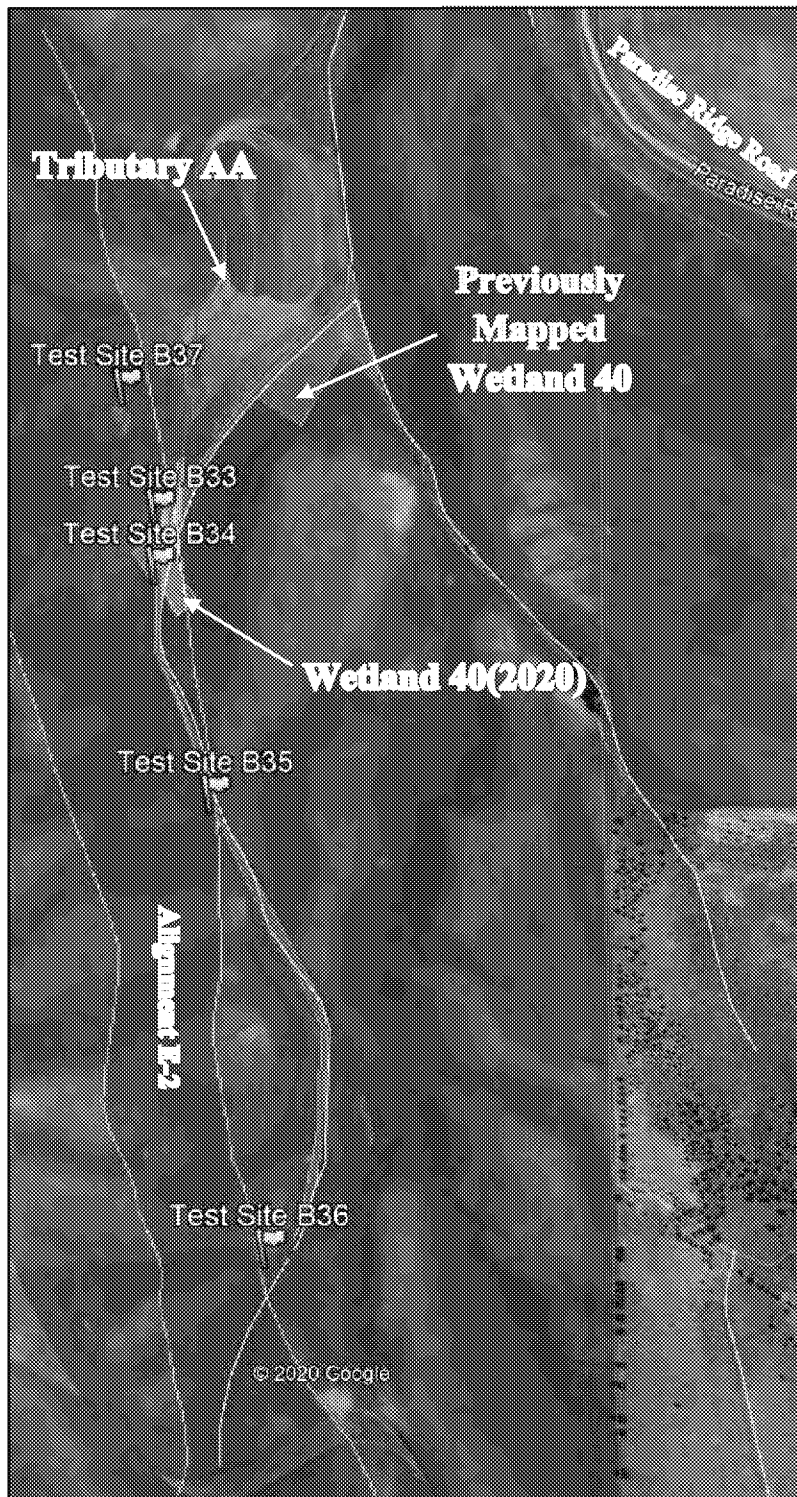
Figure 40. Location of Wetland 40(2020) and Test Sites B33, B34, B35, B36, and B37.

Test Site B33 was located in a farm field; the grasses have been sprayed out and crops planted in the adjacent field. The area looks to have been chiseled or plowed through. The test site confirms wetland presence in an area previously mapped as Wetland 40, re-delineated and referred to as Category IV slope **Wetland 40(2020)**. The emergent wetland can best be described as a farmed wetland. Wetland/nonwetland boundaries were determined with **Test Site B34** (observances in vegetation changes and soil saturation). The wetland extends downstream just out of the alignment prism into previously identified Tributary AA, although the tributary has been excavated into a different drainage pattern than previously mapped (current tributary location was mapped with GPS points in the field). A farmed drainage ditch/tributary flows in a northerly direction to the wetland and is approximately 12 inches wide and 3 inches deep; the ditch is excavated and scoured. **Test Site B35** indicates the previously mapped Wetland 40 does not extend upslope along the ditch/tributary. The ditch/tributary in this area is channelized and approximately 18 to 24 inches deep and 12 inches wide. **Test Site B36** is near the previously identified head of the ditch/tributary, although no tributary or wetland is present within the alignment in this upslope region.
